Inspection Report

Mine Name: Bingham Canyon
Operator Name: Kennecott Utah Copper

Permit number: M0350002
Inspection Date: May 4, 2006
Time: 9:45-10:20 AM

The purpose of the inspection was to look at three areas from which material may be borrowed to use in reclamation of the Bonneville Crusher area. We needed to decide whether topsoil should be saved from these areas.

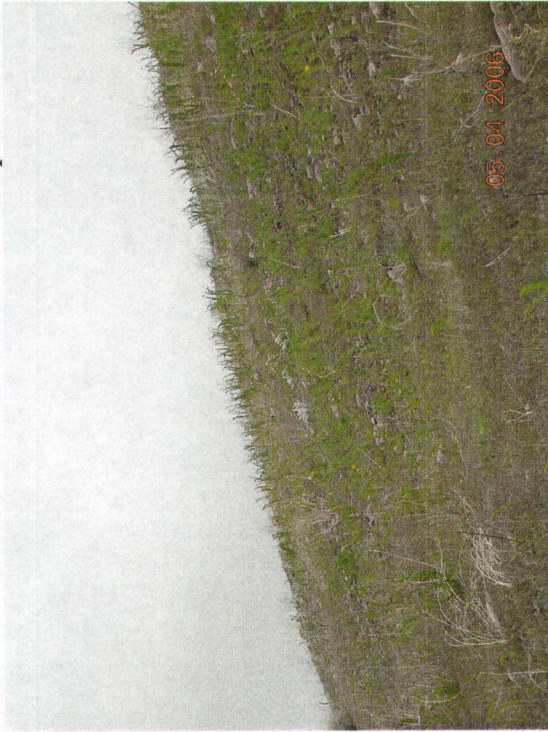
Two of the prospective borrow areas have a soil layer with some degree of organic matter accumulation. The first of these is composed mostly of alluvial material, and the second has bedrock under the soil. The third area also has alluvial material, but Mr. Payne said the surface layers have been stripped from this area. The third area, despite having had soil stripped, has the best vegetation cover, primarily introduced perennial grasses.

Photo 1. The first alluvial area where we walked.

The alluvial deposits contain enough unconsolidated material that I believe revegetation success is likely without saving soil in these areas. If the area with bedrock is used as borrow, I suggest using some of the alluvial material as soil.

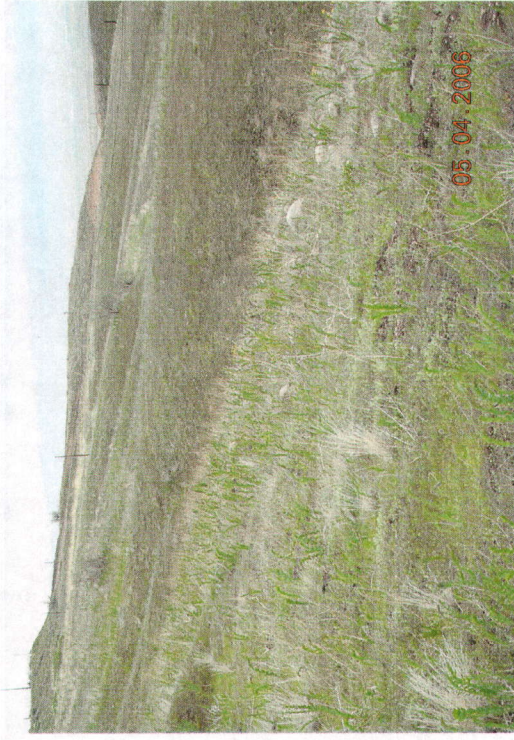
Photo 2. This area is underlain by bedrock.

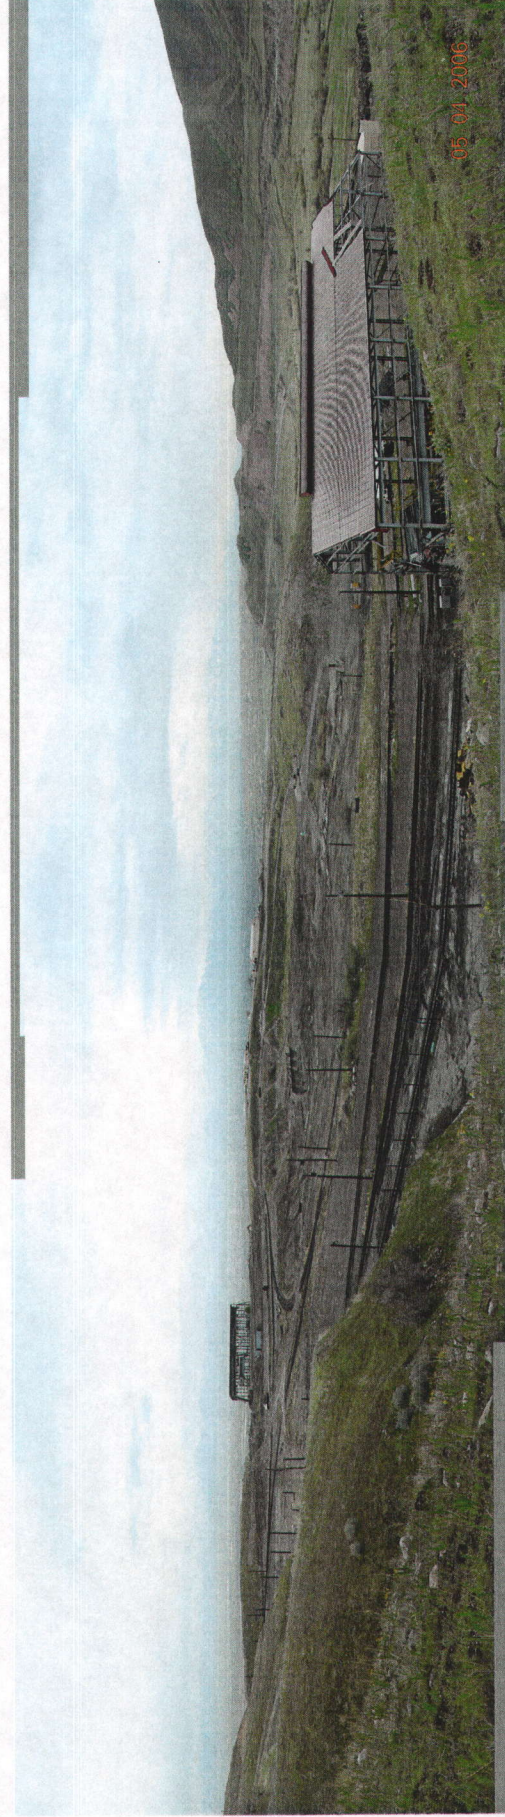
All three areas are infested with yellow toadflax, which, although it is not a noxious weed, is a species the state is trying diligently to control. The first two areas also have a fair amount of cheatgrass. Also within the area to be reclaimed are some patches of whitetop.

Photo 3. A panorama of the area being reclaimed. The bedrock area is in the foreground, the first alluvial area is near the right/center, and the second alluvial area is near the middle of the picture.

The operator should be very careful in the whitetop-infested areas to avoid spreading it.

To prevent or slow the further spread of yellow toadflax, I suggest not salvaging the topsoil. As much as possible, the topsoil should be buried.
